Mercury Flooring

The Hidden Dangers and Potential Solutions

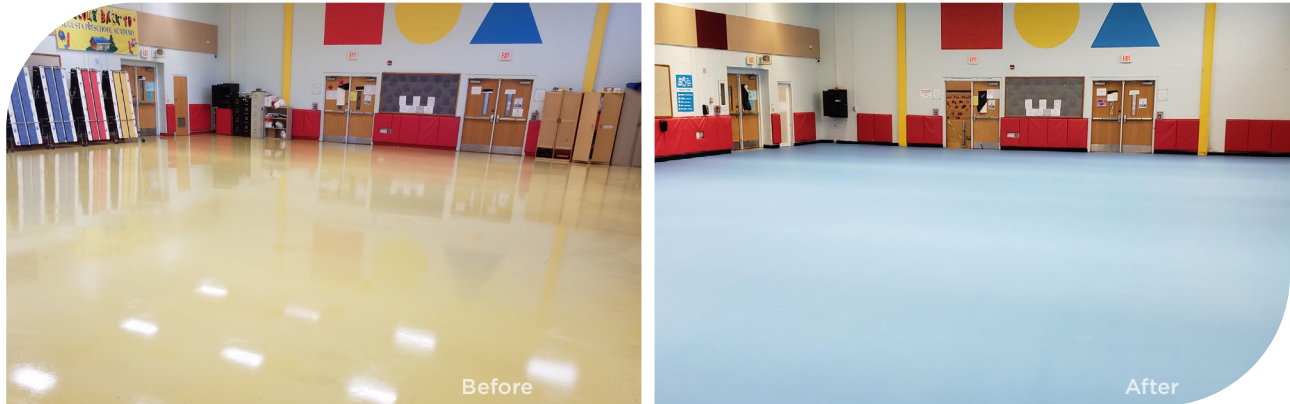
VHB worked with the New Jersey School Development Authority (NJSDA) to evaluate the potential presence of mercury-containing floors in local school district buildings. Once suspect flooring was identified, VHB's Certified Industrial Hygienist (CIH) collected samples for analysis, performed a Risk Assessment, and found mercury vapor in the indoor air at concentrations exceeding the New Jersey Department of Health (NJDOH) threshold. VHB coordinated with the school district and NJSDA in the abatement design process, performed oversight of the abatement process, and performed final clearance sampling to verify that the mercury hazard had been effectively mitigated and replaced.

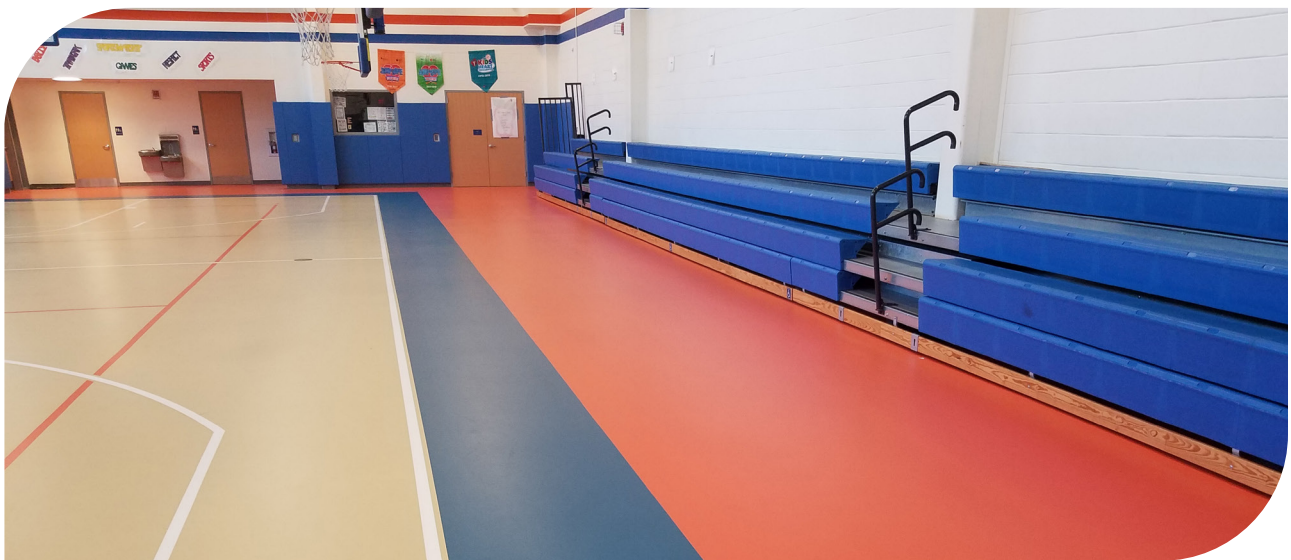
Resilient, multi-use flooring can now be installed without the use of PMA as a catalyst. VHB led the removal and disposal of PMA flooring from this school gym, as well as the abatement and replacement with safe materials.

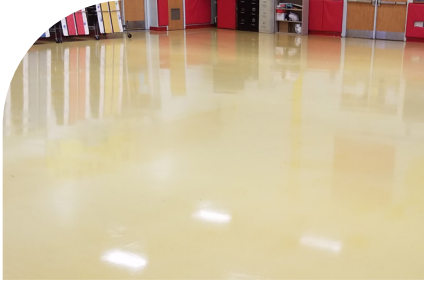
1. Identify suspect flooring

based on age, location, and material type.

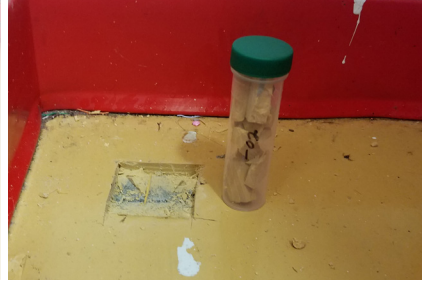
2. Collect bulk samples

from discreet locations (under bleachers, in corners, under base moldings, etc.) and perform laboratory analysis to determine if mercury is present.

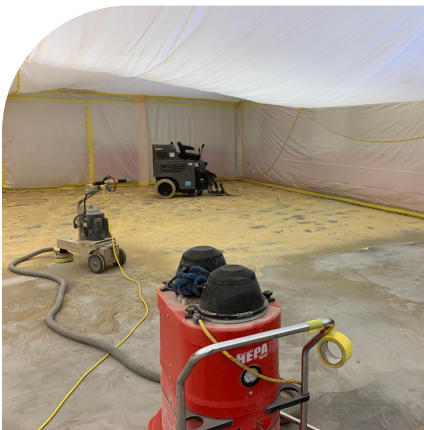
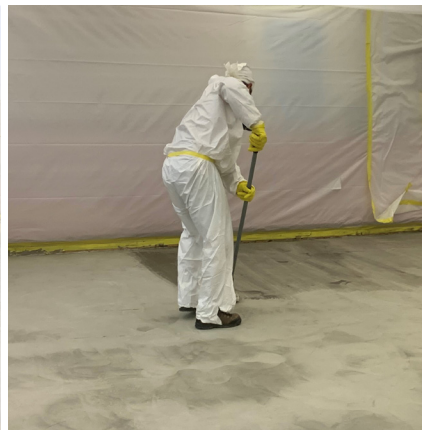
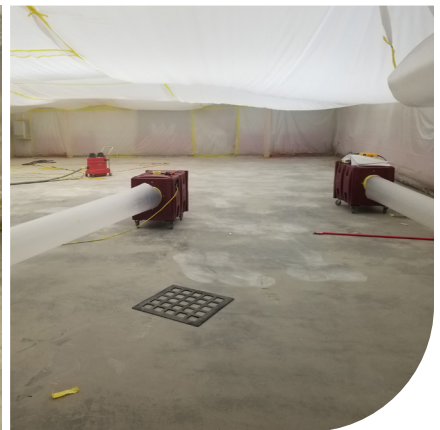
PMA flooring is removed by isolating the work area, monitoring air vapor, dust and debris control, and providing personal protection equipment for workers. Negative-pressure containment and decontamination chambers for personnel, equipment, and waste are utilized to prevent mitigation of mercury vapor or contaminated dust out of the work area.
